Pilot incapacitation occurrences 2010–2014

Research
AR-2015-096

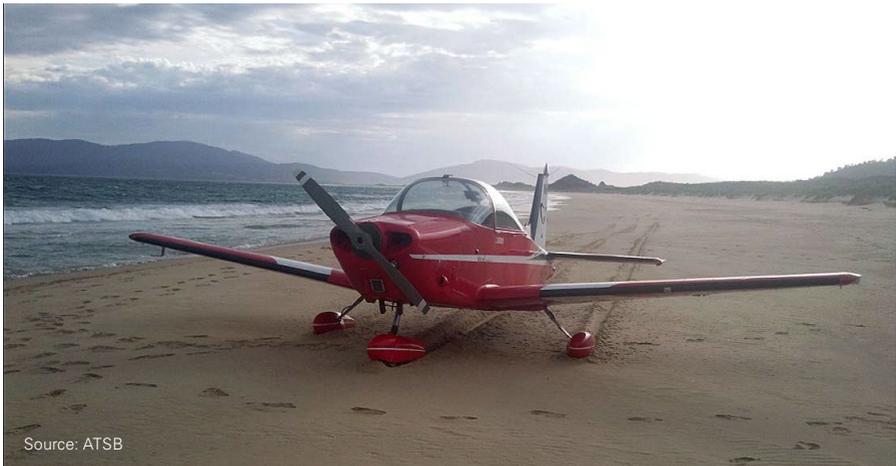
Information from the aircraft's instrumentation found that the aircraft was shut down on the beach at about 1222. An inspection by the ATSB did not find any problems with the aircraft that may have required a forced landing on the beach.

The pilot's post-mortem found the cause of death was an acute heart attack. Medical information gathered in the investigation found the pilot's DAME had been informed by the pilot of a recent cardiologist's examination that required further assessment. The DAME reported advising the pilot not to fly until a suitable intervention had been identified. It was also reported the pilot's cardiologist had advised the pilot not to fly ([ATSB investigation AO-2010-004](#)).

Victa Airtourer 115/A1 landed on North Bruny Island, Tasmania

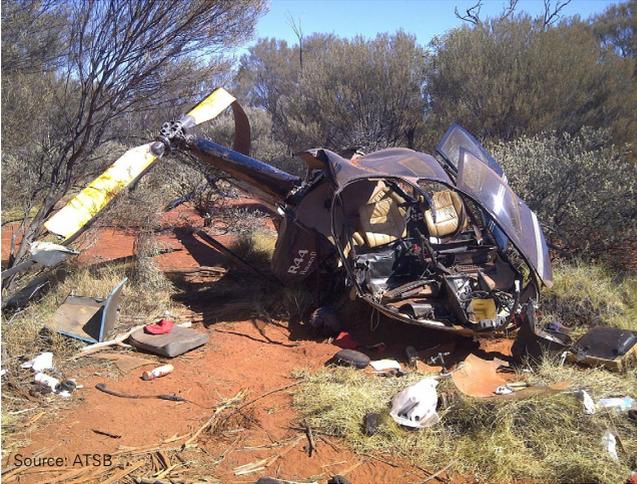
The helicopter slowed, veered right, and impacted terrain. The helicopter impacted the ground in a nose-down attitude, resulting in substantial crush damage to the underside of the helicopter's forward fuselage.

Examination of the wreckage did not identify any defects in the helicopter that would have affected normal flight. The pilot's post-mortem examination did not find any evidence of any medical conditions and the cause of death was from chest injuries sustained in the accident.

Without evidence of abnormalities in the helicopter prior to collision, it was concluded the pilot experienced a loss of consciousness episode, which prevented them from controlling the helicopter's descent before the collision with terrain ([ATSB investigation AO-2011-109](#)).

Robinson R44 accident site
